RE: Skyhawk Hangar Assessment Report

EXISTING BUILDING EVALUATION REPORT

B-24 Steel Hangar

Liberal Army Airfield, Liberal, Kansas

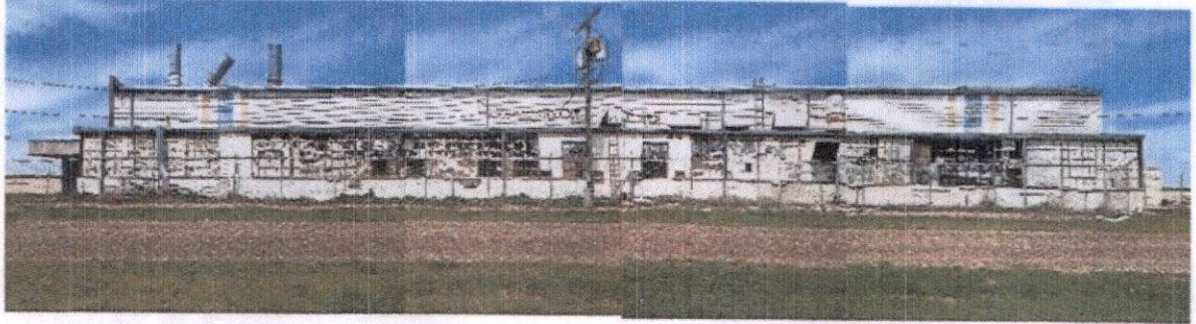
2.6.1 EAST ELEVATION (LOOKING WEST)

- The east exterior wall had broken windows and cracked gunnite on the exterior wall.
- The north exterior wall had a majority of the wall panels blown out above the missing door.

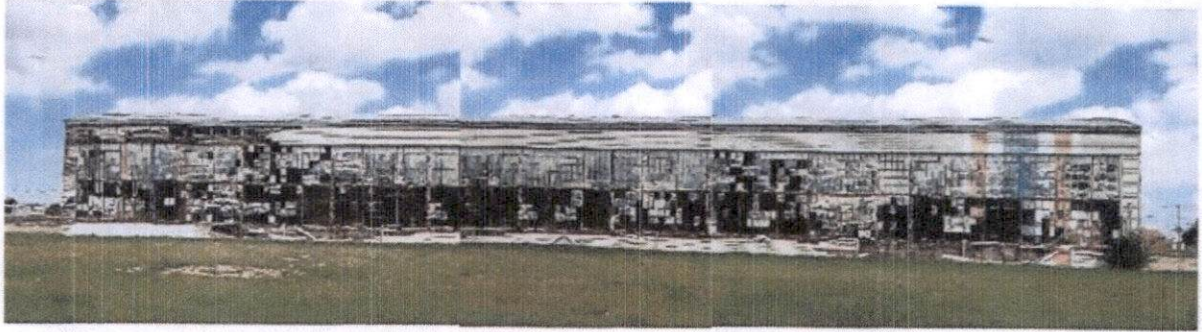
2.6.2 WEST ELEVATION (LOOKING EAST)

- The west side of the hangar receives significant surface runoff from the adjacent grass strip.
- The natural grade directs water toward the building rather than away from it.
- This condition is contributing to ongoing deterioration of the west wall, likely due to:
 - Prolonged moisture exposure
 - Ponding against the foundation
 - Infiltration into wall materials

- 2.3.1** Moisture-related deterioration is already visible on the west wall.
- 2.3.2** Continued runoff toward the building will likely worsen structural and material conditions.
- 2.3.3** Flat drainage on the north and south sides increases long-term maintenance concerns and may contribute to foundation settlement or wall moisture intrusion.

- The west exterior wall had loose glass panels, "swaying in the breeze". These panels are a safety hazard and need to be taken down.
- The bottom of the west exterior wall has rotted out and is in severe deterioration.

- Regrade the grass strip west of the hangar to establish a consistent slope directing water away from the building.
- Install a storm sewer or surface drainage system (e.g., swale, trench drain, or inlet structure) to intercept runoff before it reaches the hangar.
- Ensure the drainage system ties into an appropriate outfall or existing airport stormwater infrastructure.

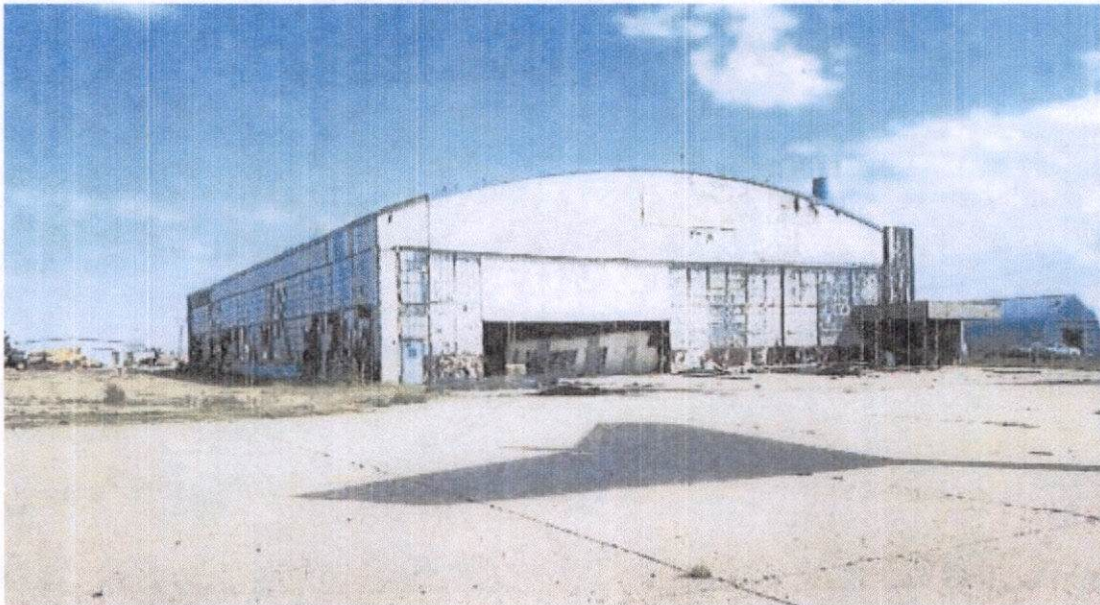
2.6.3 SOUTH ELEVATION (LOOKING NORTH)

- The north and south exterior wall doors have blown down.
 - Shoring has been added at the south door, so that if the door was reinstalled, it would not be operational.

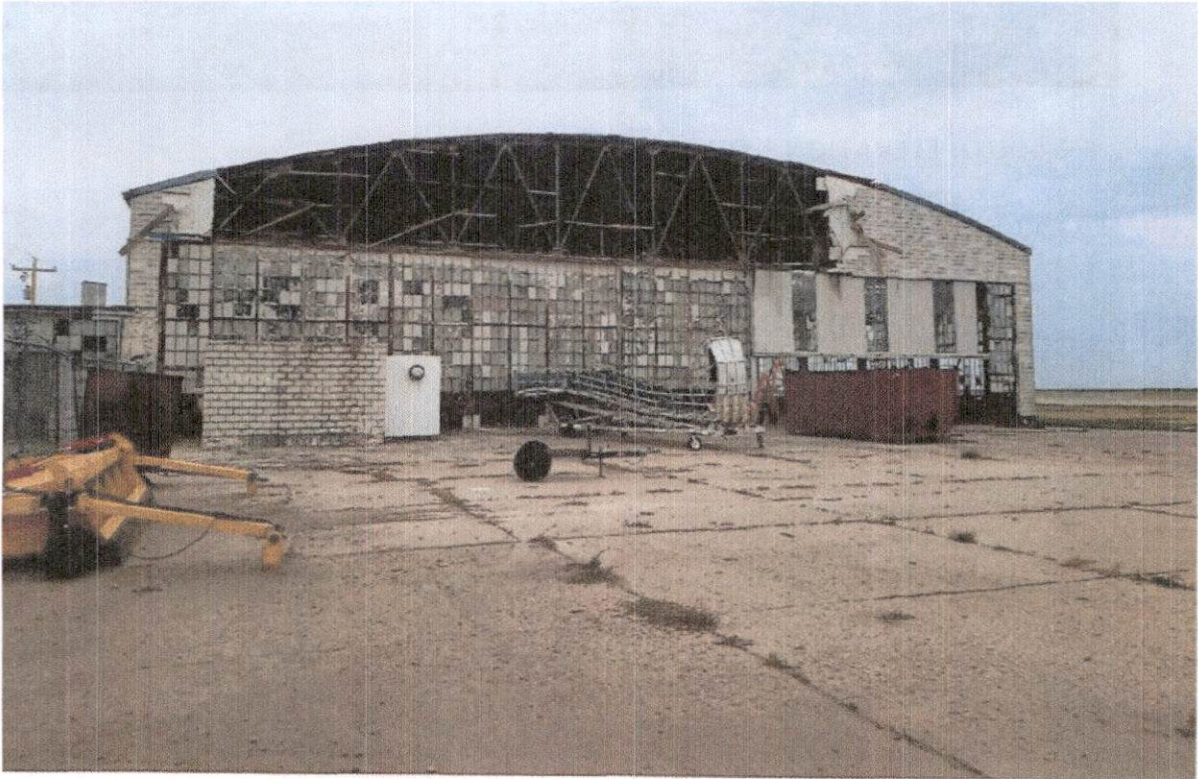
2.6.5 WINDSTORM DAMAGE

- The exterior walls of the building are in very poor condition. The north, west, and south exterior walls have all suffered significant wind and water damage. At this time, the walls are "open" and do not stop any moisture intrusion.

- Based upon my evaluation and judgment, the exterior walls all need to be replaced.
- A loose roof x-brace was noted at the middle of the south bay of the main hangar. The turnbuckle was "drooped" and not tight and in proper horizontal position.

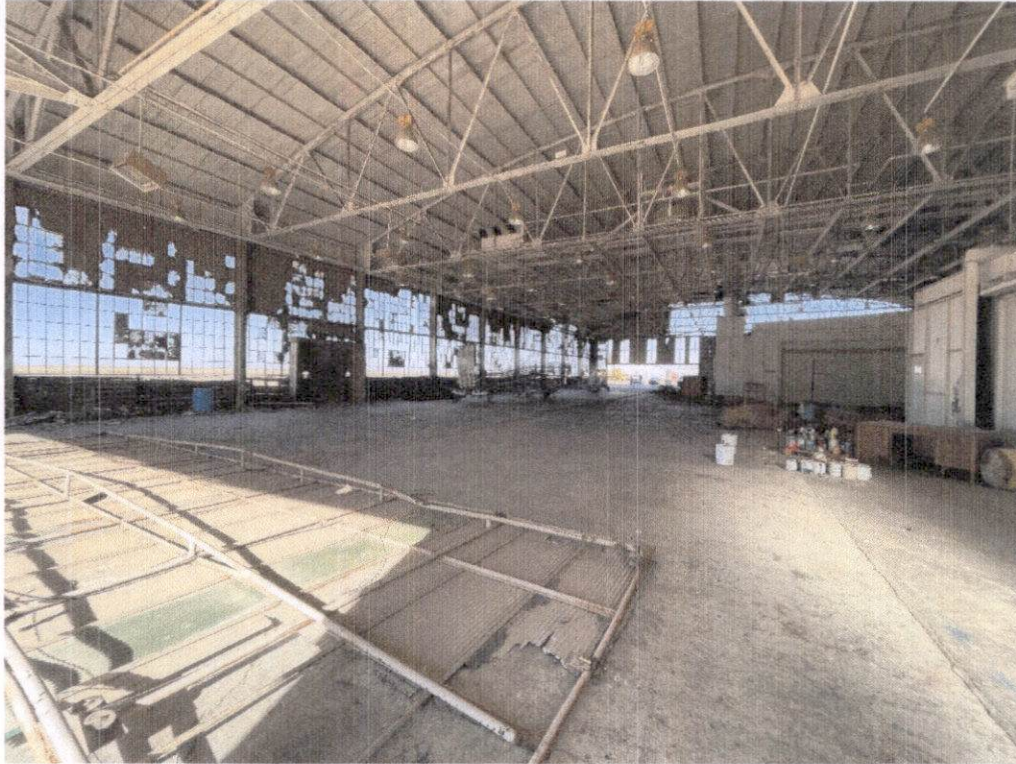
2.6.5 INTERIOR

- The roof decking and 2x roof rafters in the north (2) bays of the hangar show signs of water damage and are in various states of decay. It appears this is where the roofing has been removed and/or severely damaged. Based upon my evaluation and judgement, the existing wood roof joists and decking needs to be removed and replaced in the north two bays of the hangar.
- The majority of the roof joists appear in good condition with no major structural issues observed, with the exception of the roof joists previously noted at water damaged areas.
- The roof decking appears water damaged in various locations throughout the hangar where there has been roof leaks.

1. Remove and replace the existing wood roof in the north two bays of the hangar.
2. Reroof the entire structure.
3. Remove all the damaged exterior walls and reinstall new wall girts, siding, and/or metal panel.
4. Install new doors.
5. Exterior finishes shall be maintained at all times in order to protect the structural components they cover. Normal maintenance includes painting, caulking joints and repairing exterior finishes to prevent moisture penetration. Any components that appear to have moisture damage shall be repaired or replaced.
6. Caulk and seal all building joints as required to provide weather tightness.
7. Keep gutters and down spouts free of debris such as leaves and sticks. Downspouts and properly installed splash blocks shall deposit water away from the buildings. Water shall be deposited onto paved areas designed to direct water into the storm drainage system.
